# **SFOBB Old Spans Piers E3-E5 Implosions Project Report** **January 2017**

*San Francisco–Oakland Bay Bridge  
East Span Seismic Safety Project*

EA 04-01357

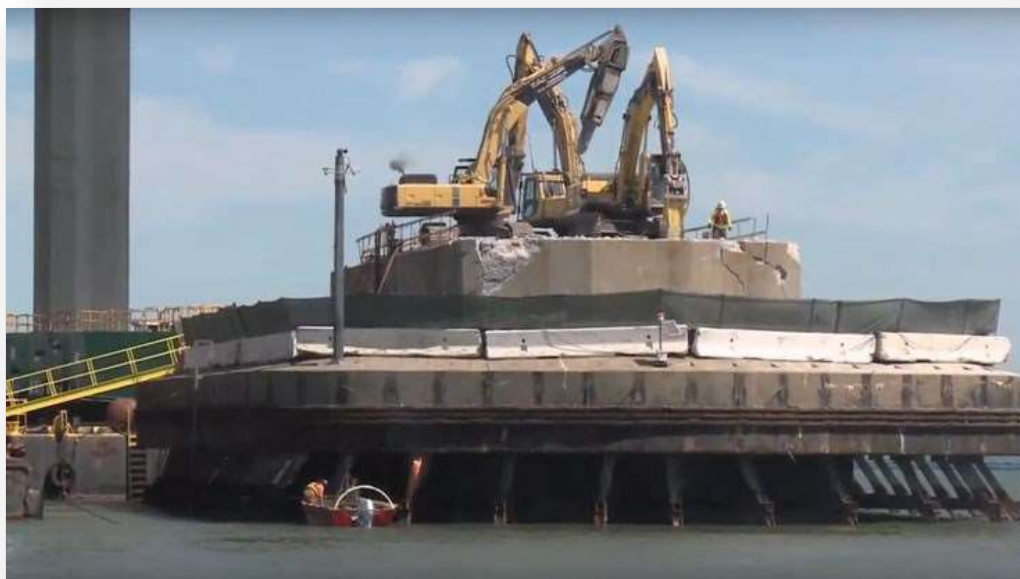
**Figure 2-3. Mechanical Removal of Concrete Above Pier Cap (Pier E3 Shown)**

The blaster-in-charge also was responsible for outlining (designing) the sequences and procedures for each blast, for the safety of all personnel involved. Following mechanical removal of concrete above the pier cap (Figure 2-3) and after the drilling of holes was completed (Figure 2-4), the blast columns were ready for loading. The explosive material was transported to the project site in accordance with all applicable regulations and permits required for the project. The project site and each individual pier were secured as required throughout this process. On completion of the loading of charges, the initiation circuit from hole to hole was completed and tested to ensure that all holes would fire in accordance with the designed sequence. Blast mats were secured to ensure that fly rock would be minimized. All loading operations were planned and completed to allow the blast event to occur at high slack tide, so that the water currents were at a minimum and to optimize the effectiveness of the BAS.

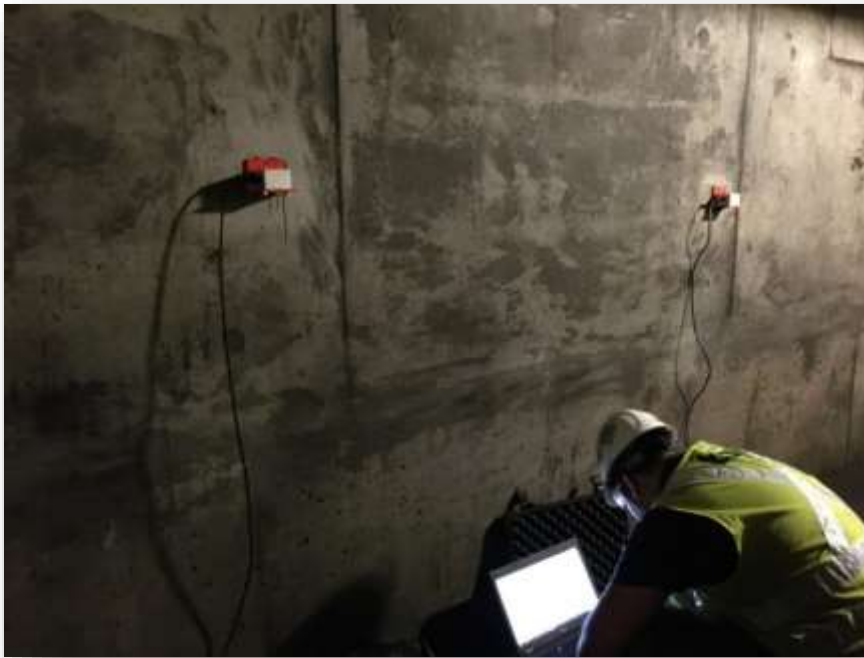
Figure 4-4. Vibration Sensors on the BART Transbay Tube Wall

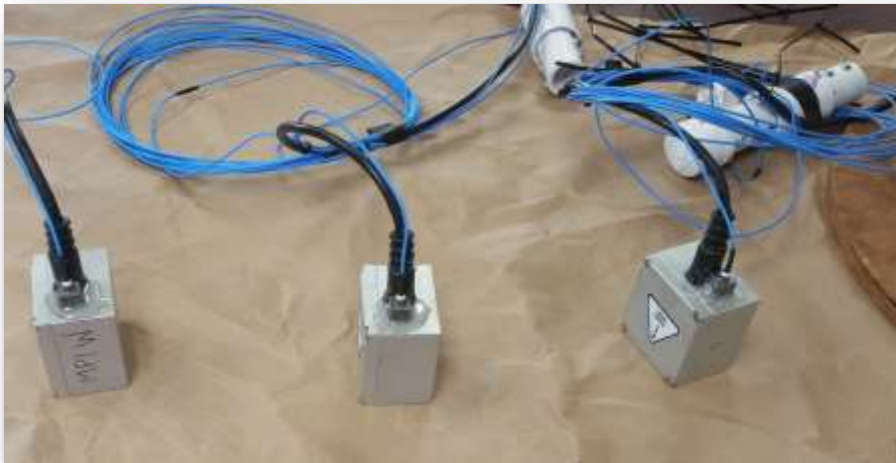
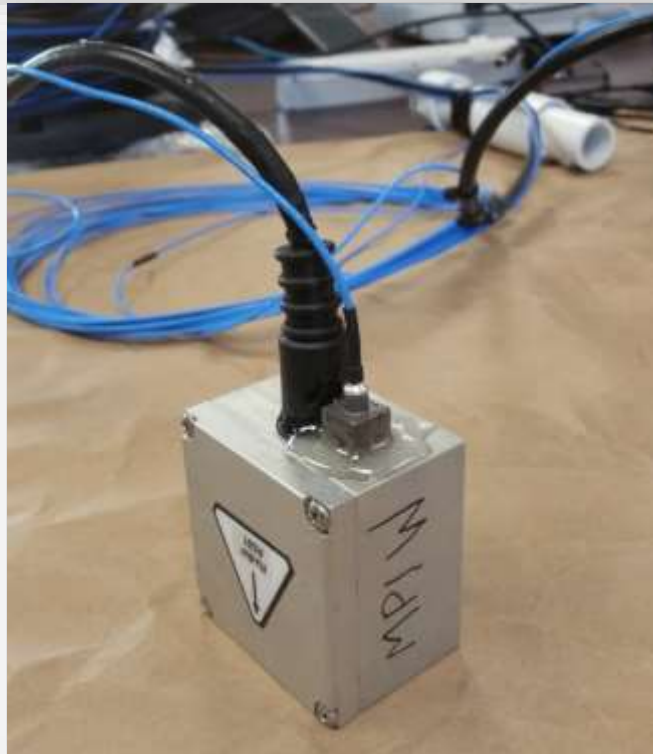
**Figure 4-11. Geophone and Accelerometer**

The geophones are connected to the black cables; the accelerometers are connected to the blue cables.

Blast vibration measurements of the outfall pipe were made at three monitoring points (MP)—MP1, MP2, and MP3—as shown in Figure 4-10. One tri-axial velocity geophone and one tri-axial accelerometer were epoxied together and attached to a diffuser opening at each of the three monitoring locations, using a clamp. Figure 4-11 shows the geophone and accelerometer that were used for monitoring.

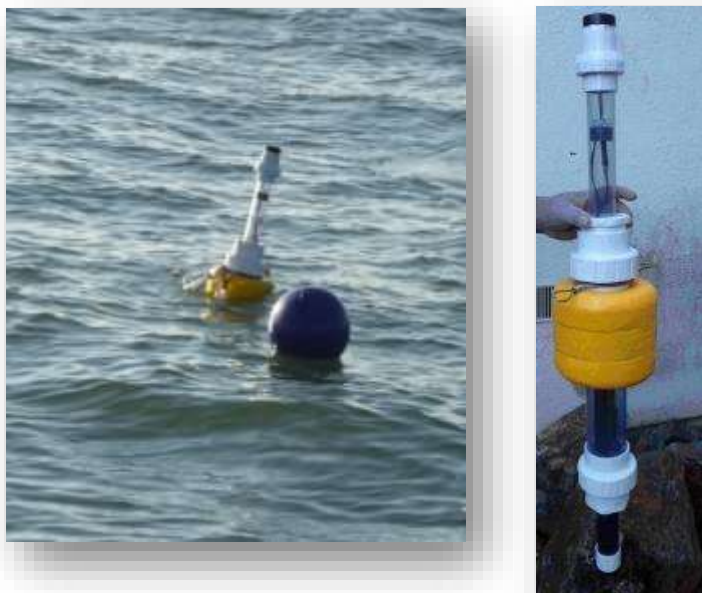
**Figure 5-1. Current Tracking Drift Drogue**

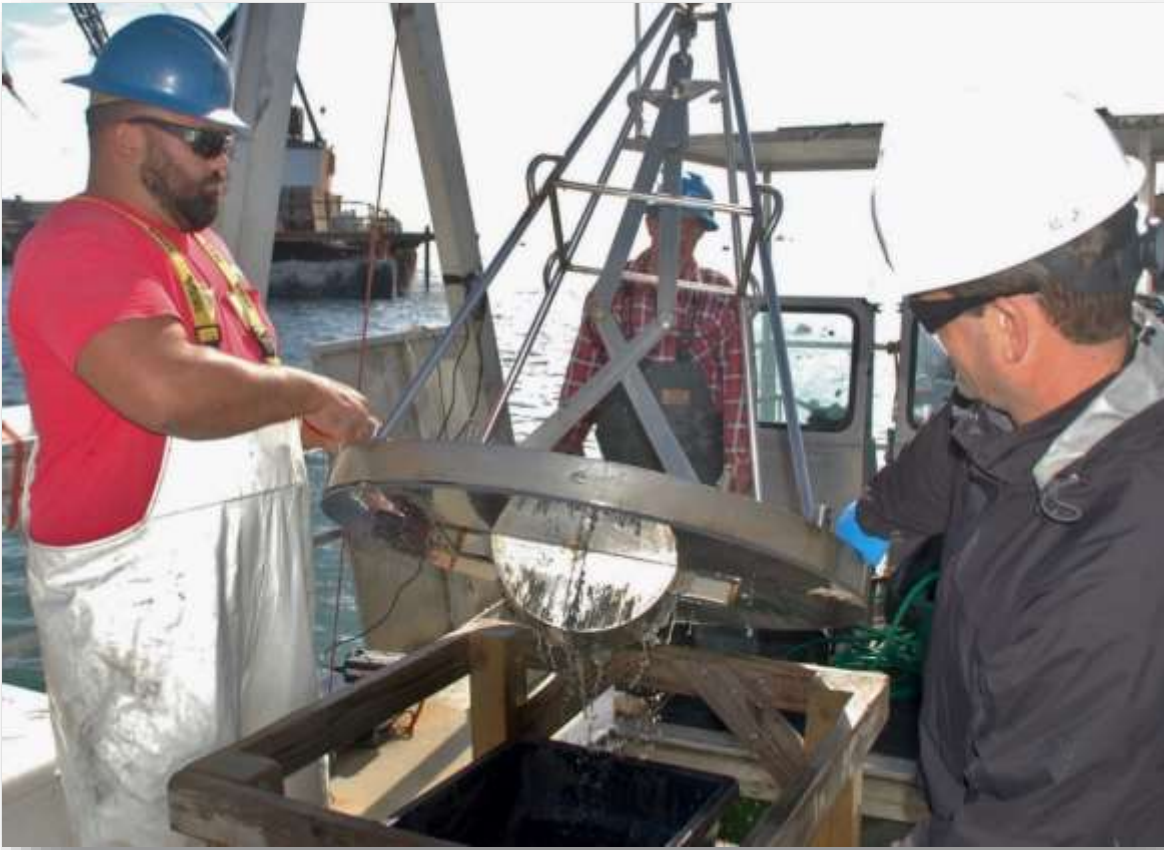
**Figure 5-2. Van Veen Sediment Sampling Equipment**

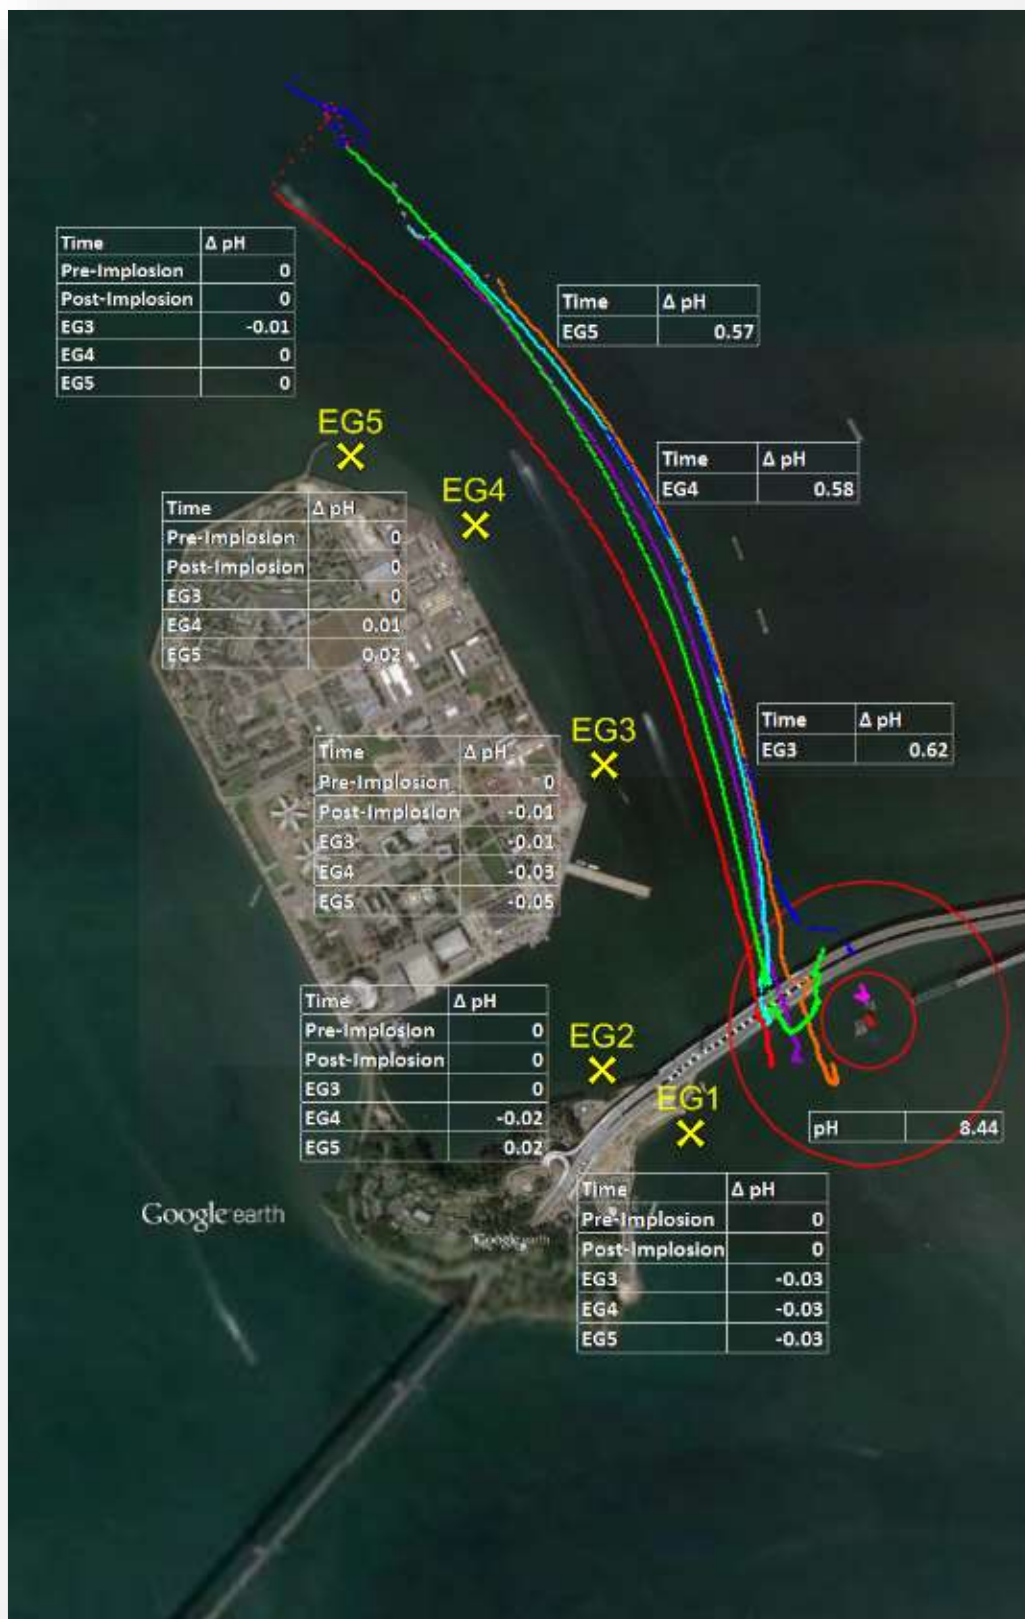
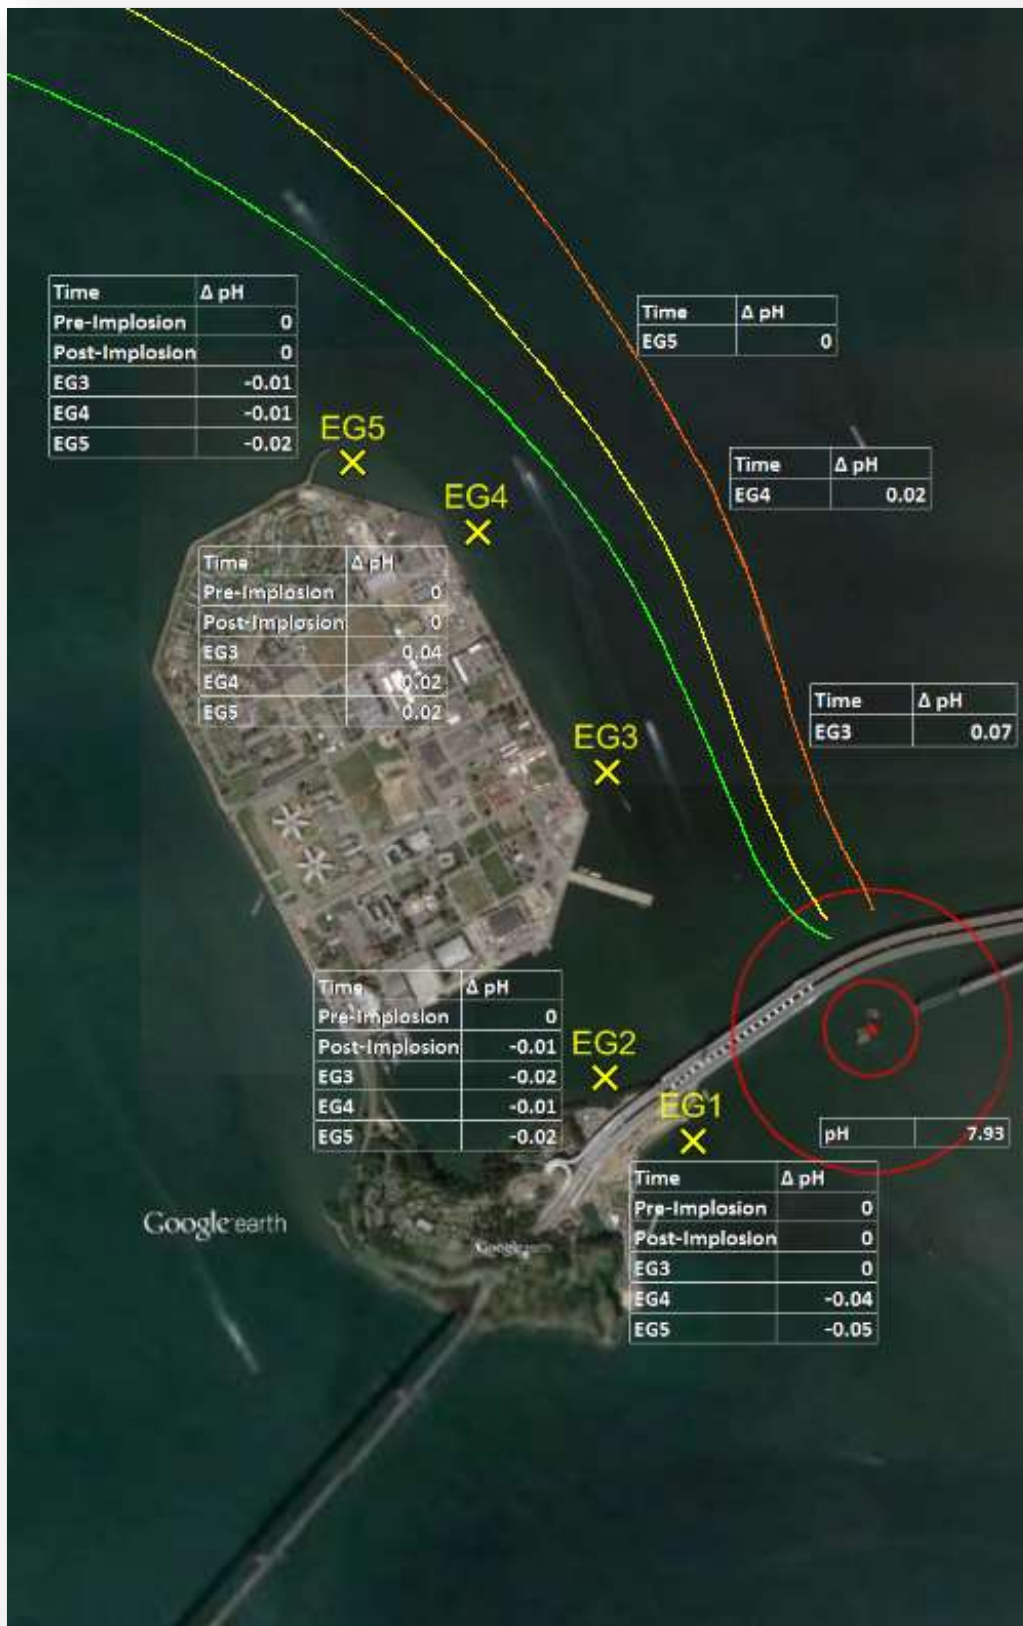
Throughout the post-Pier E4 implosion monitoring period, the pH change at the eelgrass monitoring stations is considered negligible. The highest pH observed in the vicinity of the implosion immediately after the blast was 8.44. The data shows that the pH in the plume dropped by 0.62 pH units to 7.82, which is considered the background level, by the time the plume was aligned with EG3.

Figure 5-4. Pier E4 Implosion pH Measurements and Plume Tracking

Figure 5-5. Pier E5 Implosion pH Measurements and Plume Tracking

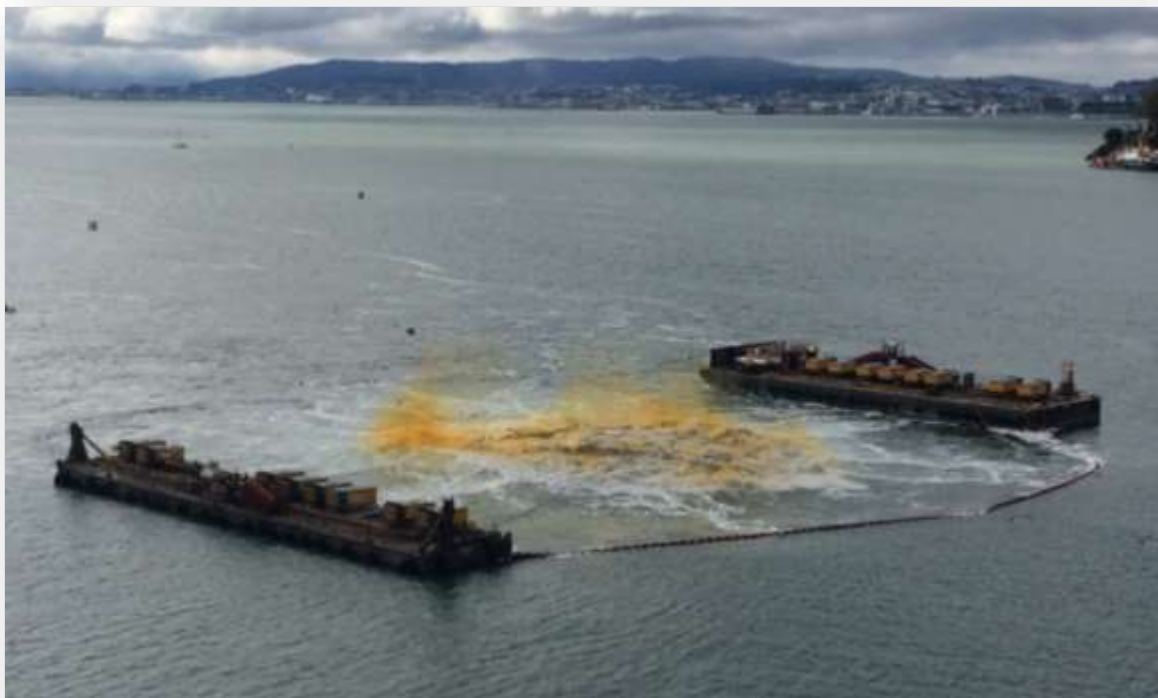
During both the Pier E4 and Pier E5 implosions, an air emission consisting of a yellowish orange plume with some grayish color was observed just above the pier after each implosion (Figure 5-6). This emission rapidly dispersed and settled in minutes, and completely disappeared within 10 minutes. Based on the limited extent and duration of the emission, this emission is considered de minimis.

**Figure 5-6. Air Emission Following Pier Implosion**

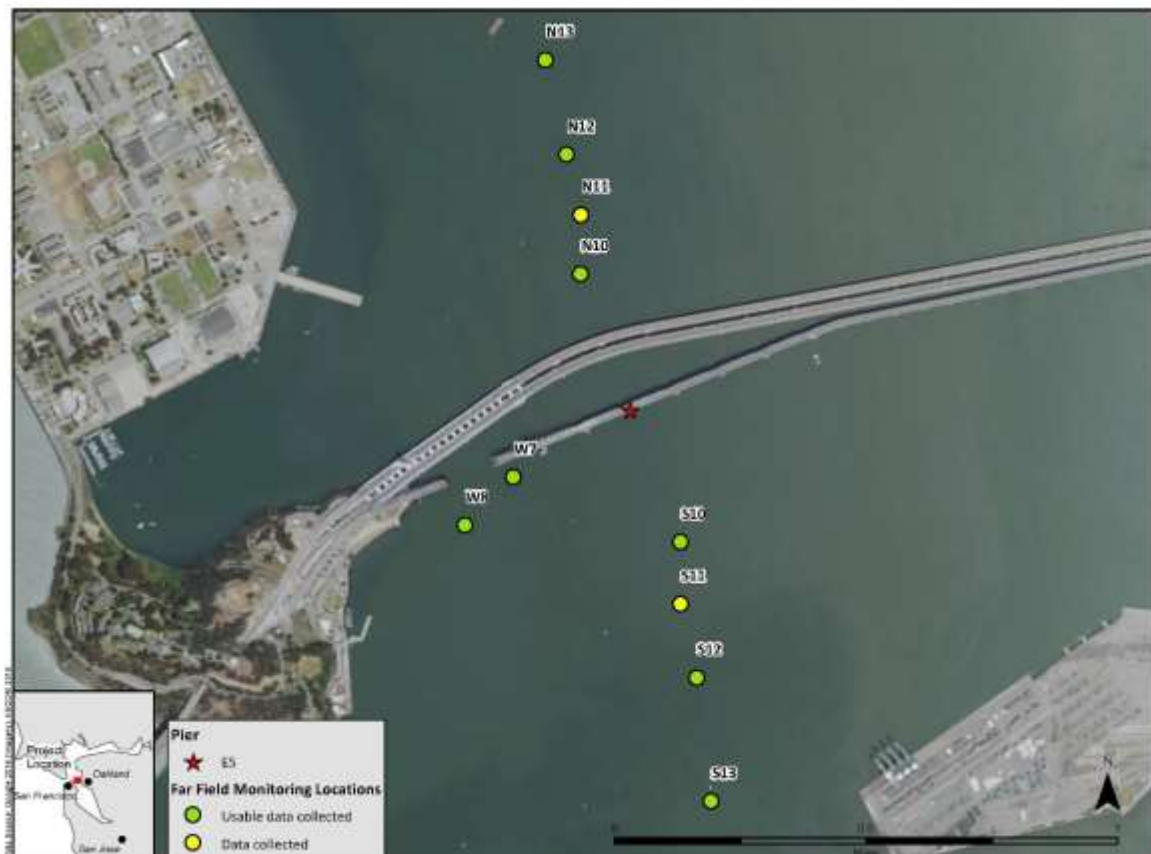
For the Pier E5 implosion event, data was successfully captured at eight locations, as shown in Figure 6-3. Successful measurements were made at the locations indicated in Table 6-3.

**Figure 6-3. Pier E5 Deployed at Far-Field Monitoring Locations Where Data Was Collected**

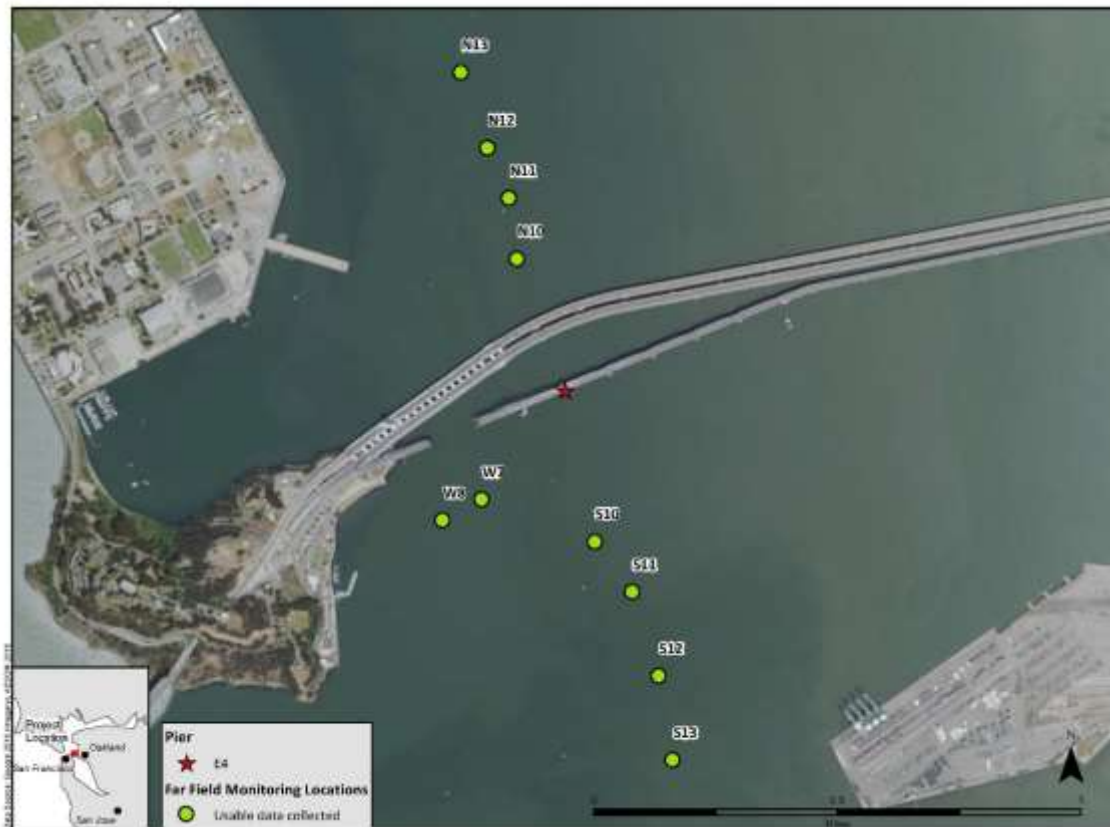
Far-field monitoring for Pier E4 was planned at the same 10 locations discussed for Pier E5 along the north, south, and west lines, and shown in Figure 6-1. Successful measurements were made at each location, with actual distances for each directional array shown in Table 6-3. Figure 6-5 shows the measured locations made in the far-field monitoring during the Pier E4 implosion.

**Figure 6-5. Pier E4 Deployed at Far-Field Monitoring Locations Where Data Was Collected**

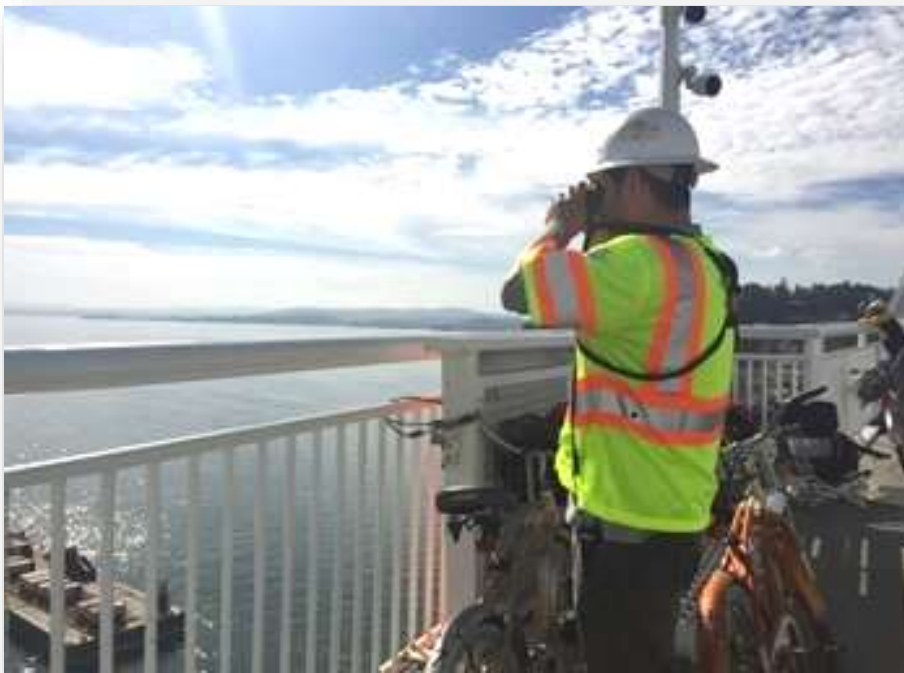
**Figure 6-17. Biological Monitor on New San Francisco–Oakland Bay Bridge**

All MMOs were equipped with radios, using a dedicated marine mammal monitoring channel with mobile phones as a back-up (Figure 6-17).

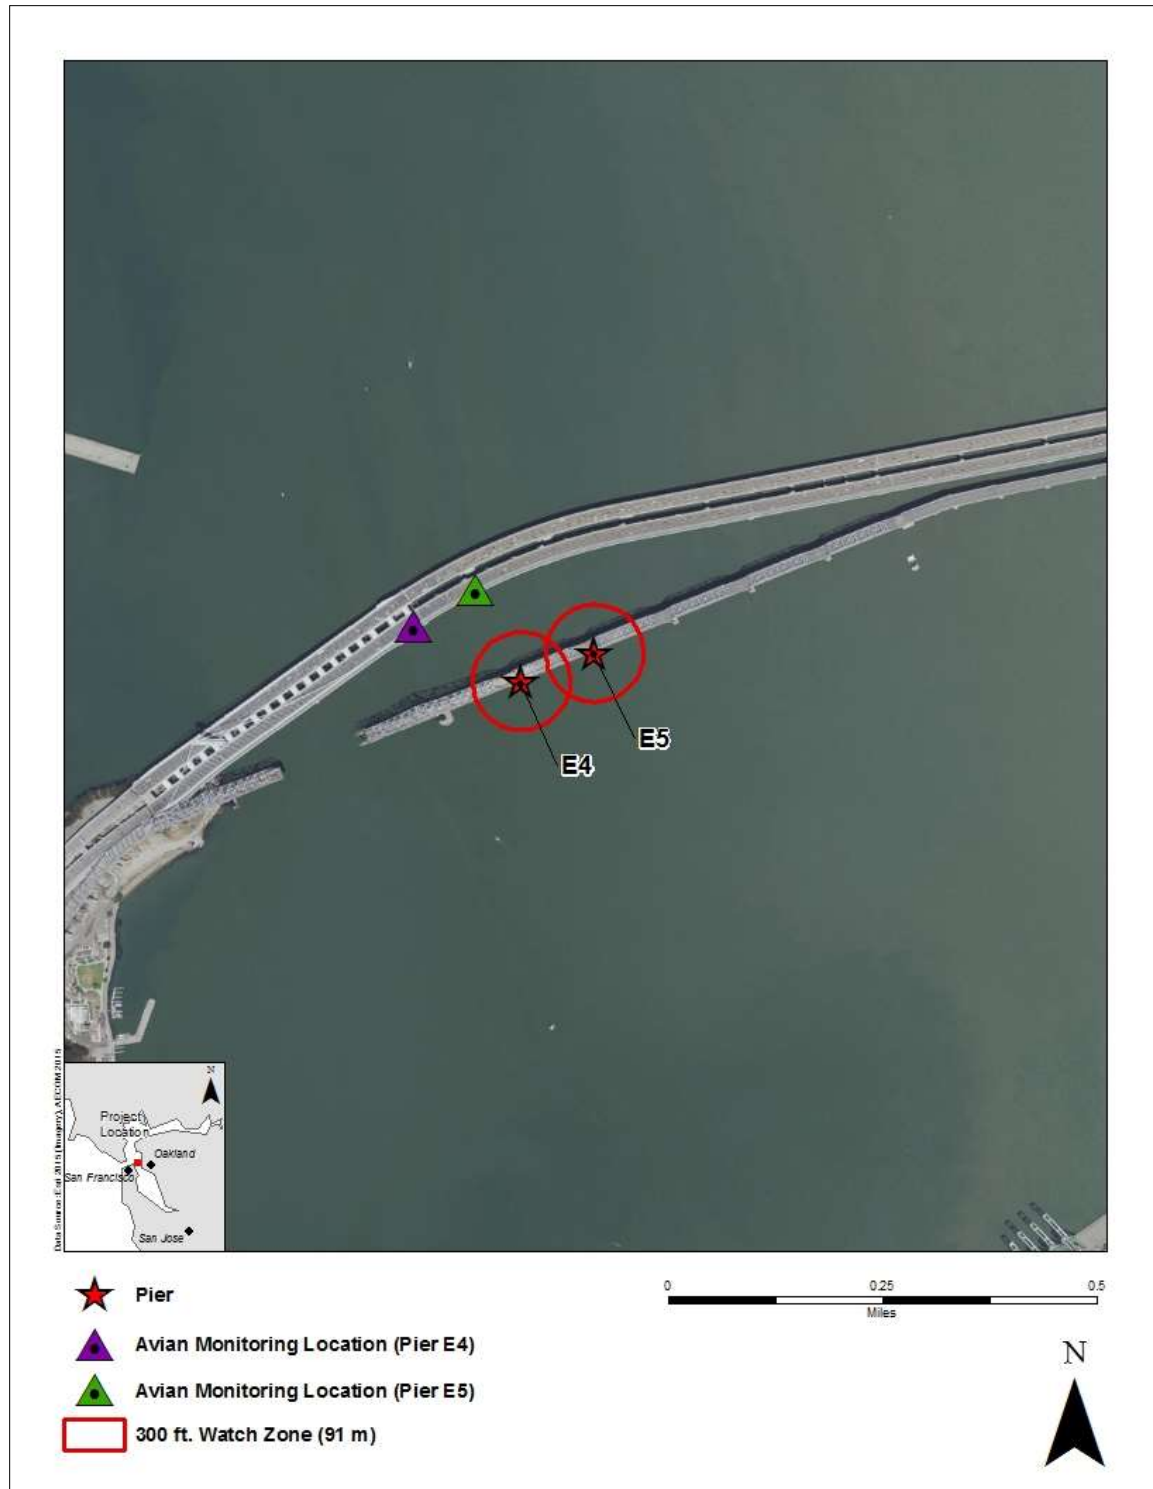
**Figure 6-18. Avian Monitoring Locations and Watch Zones for Piers E4 and E5**

cSEL threshold was measured at approximately 300 feet from the pier during the implosion of Pier E3. The Department took the conservative approach of applying the measured distance to the avian auditory injury threshold for Pier E3 to the avian watch zone for Piers E4 and E5. The 300-foot avian watch zone was implemented and monitored to protect special-status diving birds during each controlled blasting event (Figure 6-18). To avoid impacts, the Department used deterrents (i.e., sound cannons) to encourage target avian species to relocate from the 300-foot Avian Watch Zone.

Avian monitoring for the Pier E5 implosion was conducted from 10 a.m. to 12:50 p.m. on October 15, 2016. Three biologists monitored the 300-foot Avian Watch Zone and surrounding area for bird activity before, during, and after the implosion of Pier E5 (see Figure 6-18). One minute before the blast, the Department fired a remote-controlled sound cannon designed to deter birds from the area, from a barge approximately 100 feet west of Pier E5. The blast occurred at 11:57 a.m. Wind speed over the water picked up significantly after the blast.

Avian monitoring for the Pier E4 implosion was conducted from 9:30 a.m. to 12:02 p.m. on October 29, 2016. Three biologists monitored the 300-foot Avian Watch Zone and surrounding area for bird activity before, during, and after the implosion of Pier E4 (see Figure 6-18). At 11:20 a.m., the Department fired a remote-controlled sound cannon designed to deter birds from the area, from a barge approximately 100 feet west of Pier E4. The blast occurred at 11:57 a.m.

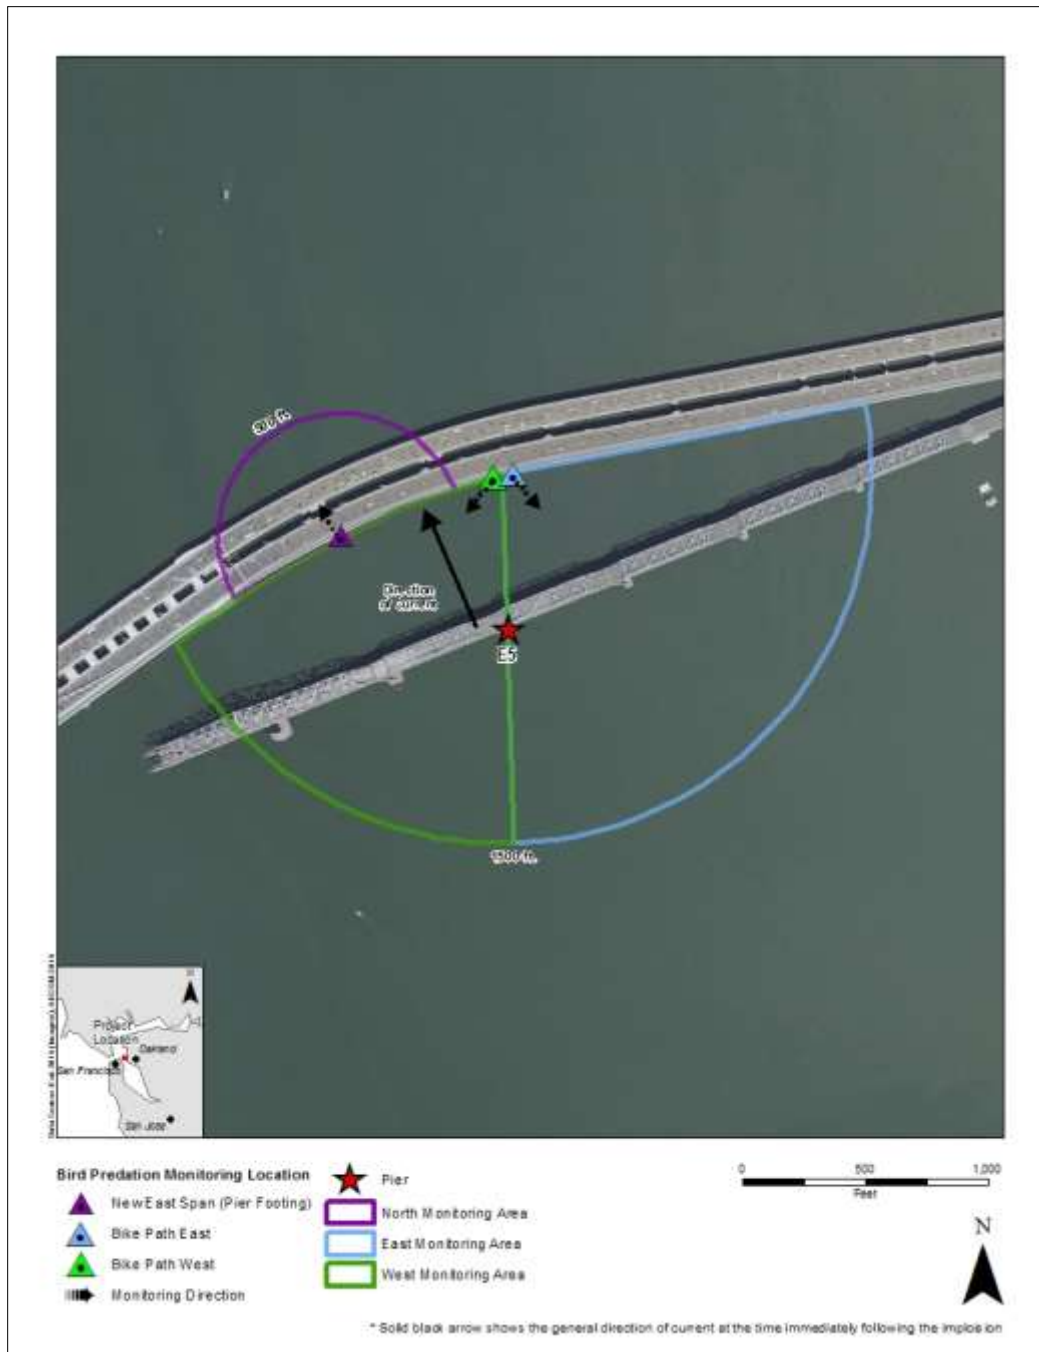
**Figure 6-19. Pier E5 Bird Predation Monitoring Locations**

areas west of Pier E5. A third monitor was positioned beneath the westbound skyway on the footing of Pier E3 of the new East Span near the water level, and surveyed the area under the new bridge structure, facing north. Figure 6-19 shows the locations of each bird predation monitor and the general survey area.

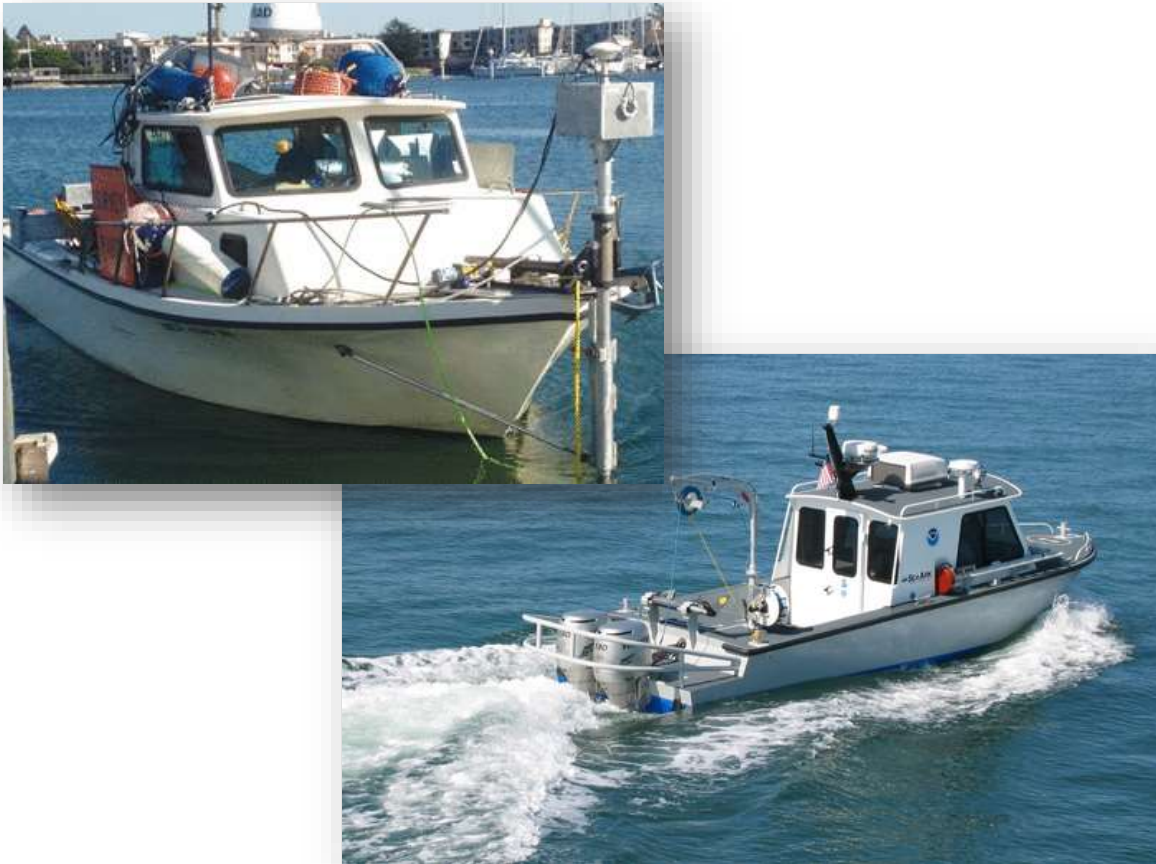
Figure 7-1. Typical Vessels for Conducting Side-Scan Sonar Survey

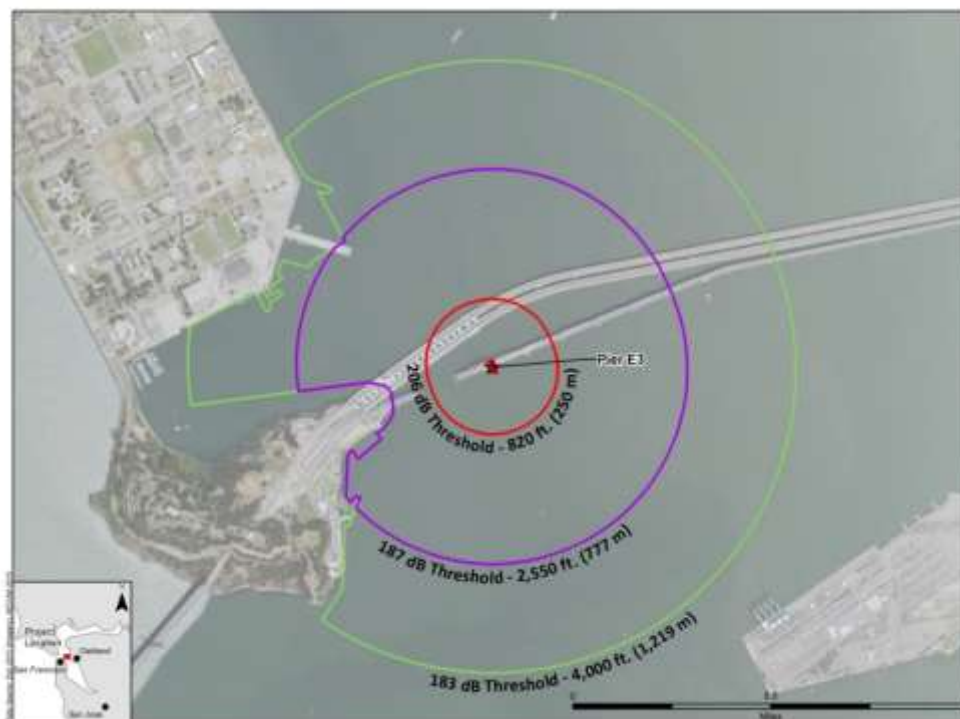
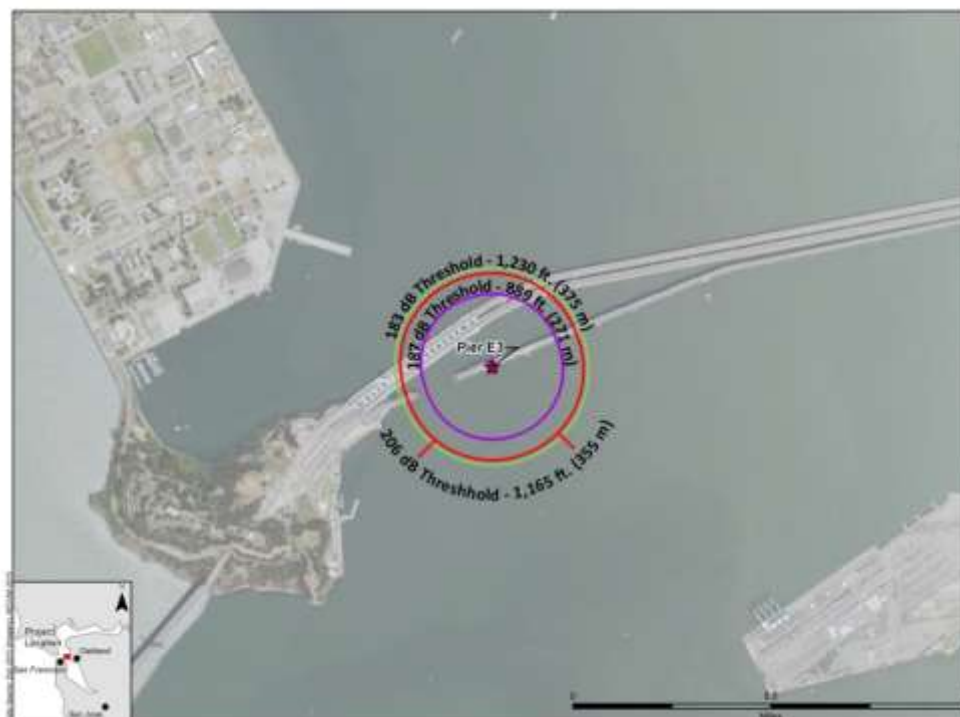
Figure 7-10. Modeled Isopleths to Fish Threshold Criteria, Pier E3

Figure 7-11. Measured Isopleths to Fish Threshold Criteria, Pier E3

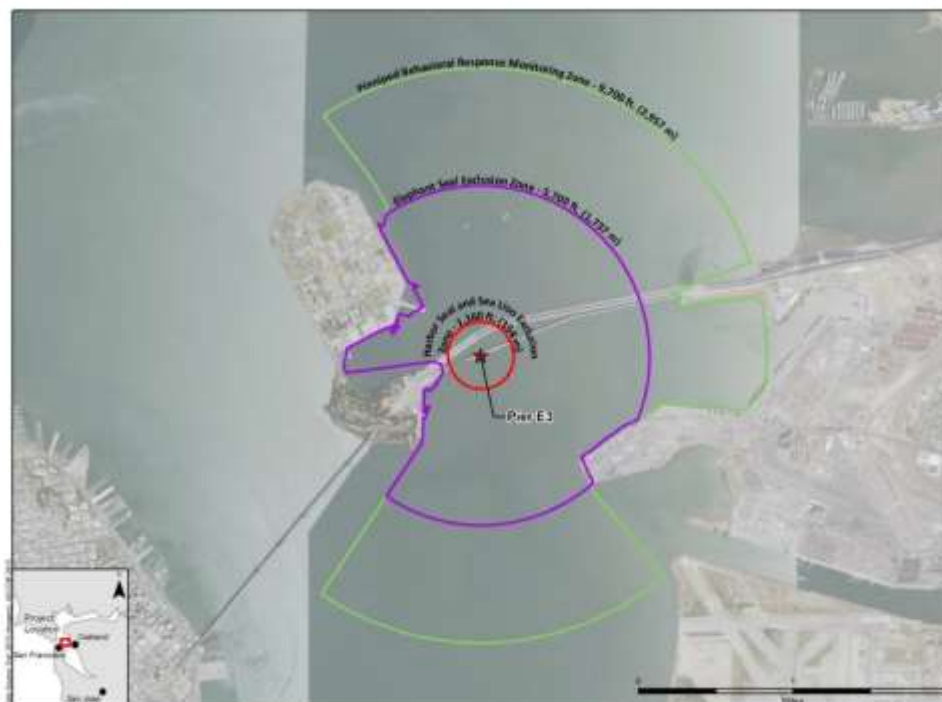
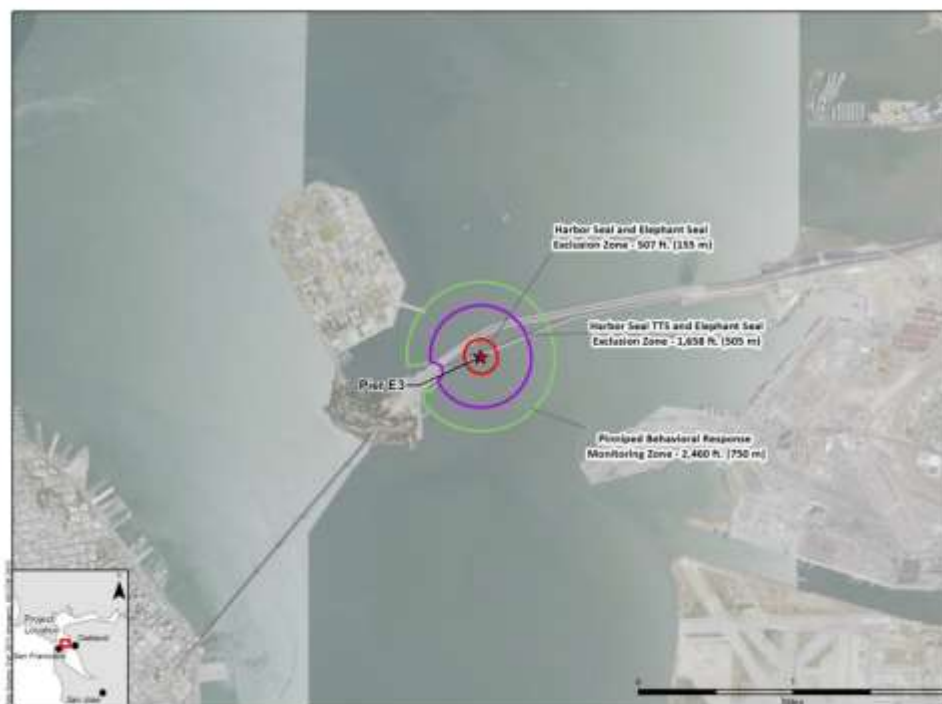
**Figure 7-12. Modeled Isopleths to Pinniped Threshold Criteria, Pier E3**

**Figure 7-13. Measured Isopleths to Pinniped Threshold Criteria, Pier E3**

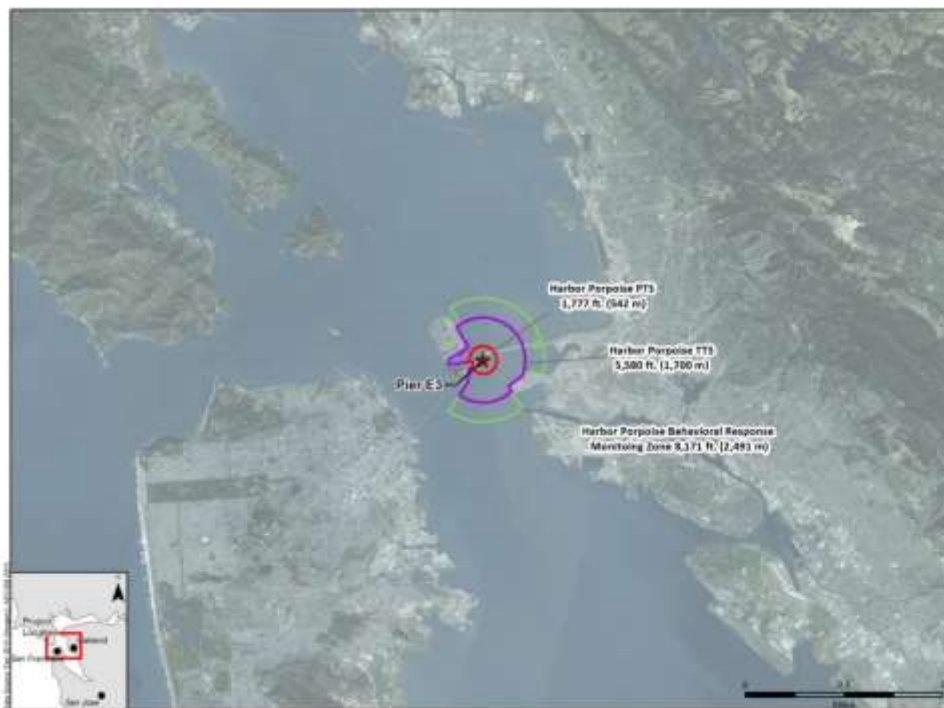
Figure 7-14. Modeled Isopleths to HF Porpoise Threshold Criteria, Pier E3

Figure 7-15. Measured Isopleths to HF Porpoise Threshold Criteria, Pier E3
